# CASE STUDY

## Lamson blower

Steven A. Head

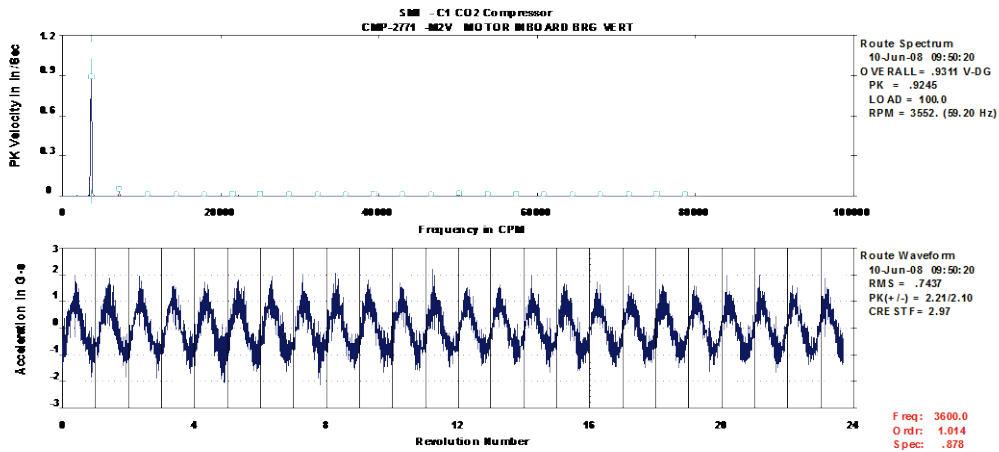
In June 2008 the Lamson motor was replaced. That month a validation of the new motor was conducted and the motor was found to be unsatisfactory. Vibration measurements revealed .9 in/sec in the motor inboard vertical position. Phase readings across the coupling were 155°. Maintenance personnel were informed of the findings and a recommendation was made to align the unit. Additionally, an acid cleaning of the blower was recommended to reduce imbalance in the blower.

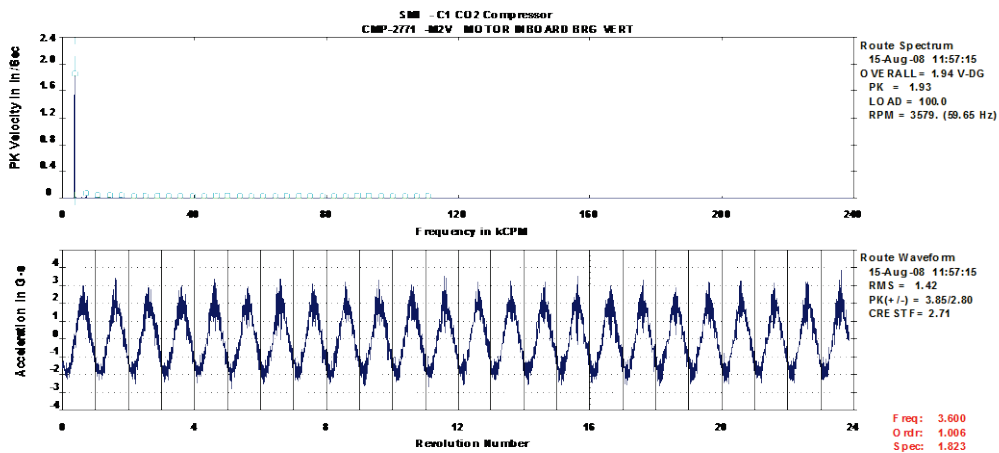
No action was taken to correct the deficiency in June, July or August and the vertical measurements increased to approximately 1.6 in/sec.

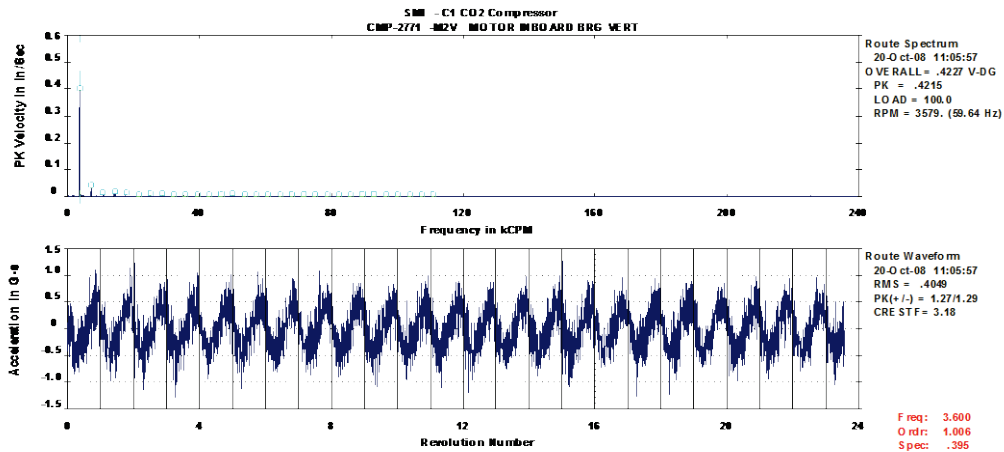
In September the unit was cleaned and aligned bring the vibration levels down to .39 in/second, which is within the company specification of .5 in/sec. and waveform P-P vibration was reduced from >6 g's to under 3 g's.

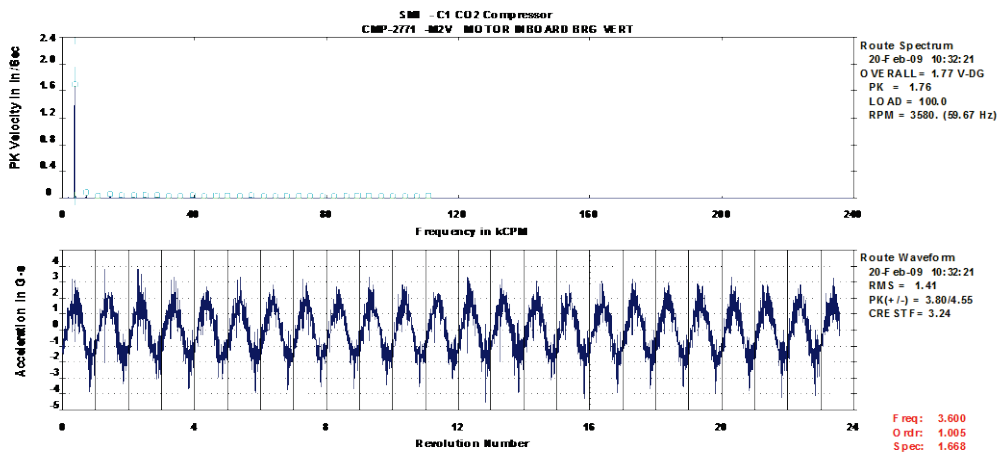
By February 2009 the symptoms had returned to the original levels. Again a Cleaning and alignment was recommended as they had corrected the original problem with the added recommendation of leveling the frame and checking the unit for a soft foot condition.

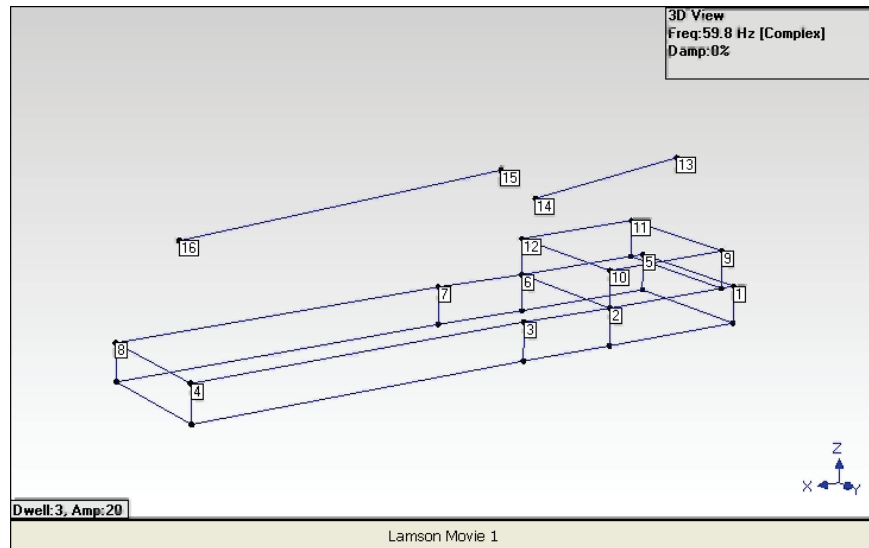
In Mach an independent ODS was performed to analyze the frame. The results revealed that the motor and blower were off-set misaligned and thus inducing heavy vibration.

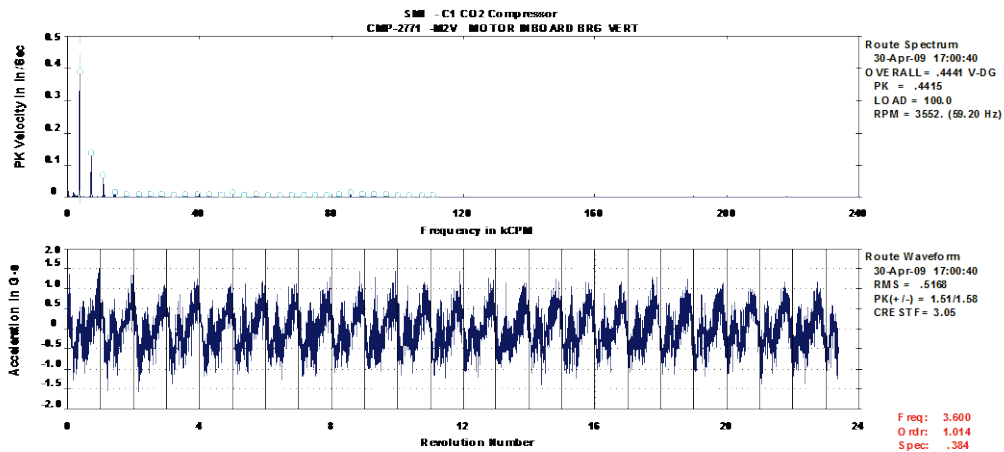
In April 2009 an in-depth analysis with corrective action was undertaken to include: frame leveling, aligning, cleaning, and checking for soft foot. Vibration levels in the vertical plane were in excess of 3.3 in/sec (not a typo) with phase readings of 178° across the coupling. The alignment was checked on the spot and found to be well within tolerance.

A new approach was needed to identify the source of the problem. The motor feet were loosened one foot at a time and when the right foot closest to the coupling was loosened the vibration dropped to .38 in/sec. Initial thought was it had an undetected soft foot. Shims were placed under the foot and the foot tightened. After two attempts to shim the motor failed to bring the vibration level within acceptable limits, it was noted that tightening the foot bolt, raised the vibration levels back over 3 in/sec.

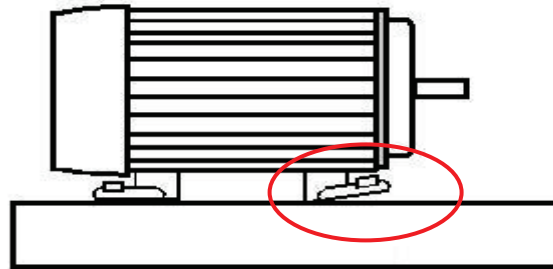
With the motor bolt removed, a visual inspection was conducted and found the motor foot to be bent approximately  $5^{\circ}$ . It was determined that the motor bolt, when tighten, distorted the motor frame thus inducing the high vibration levels.

The company is researching to determine if the motor is still under rebuild warranty.
